## **INTENSIVE LEVEL SURVEY of Historic Resources**

South Cayuga Road Corridor  
Williamsville, New York

**INTENSIVE LEVEL SURVEY  
of Historic Resources**

*for the*  
**SOUTH CAYUGA ROAD CORRIDOR**  
Williamsville, NY

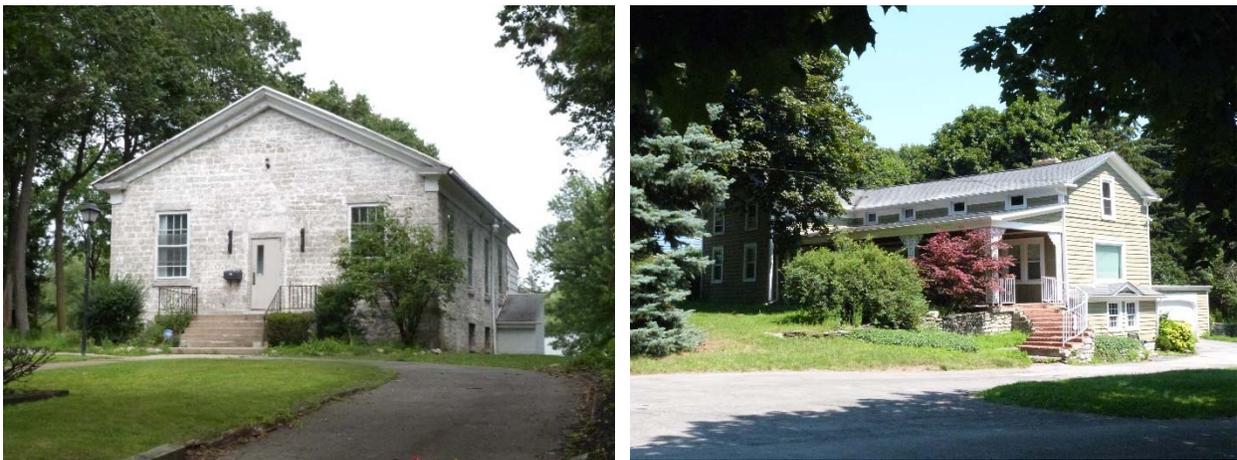
Figure 4-1. Examples of the Greek Revival style along S. Cayuga Rd. Left: 72 S. Cayuga (Hopkins Schoolhouse), Right: 204 S. Cayuga Rd. (Gardner Green House)

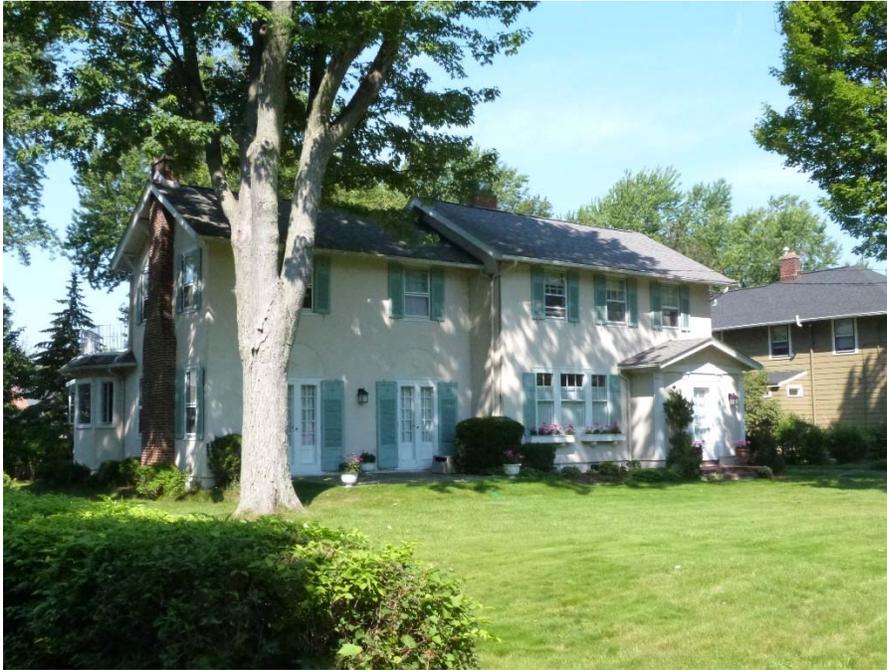
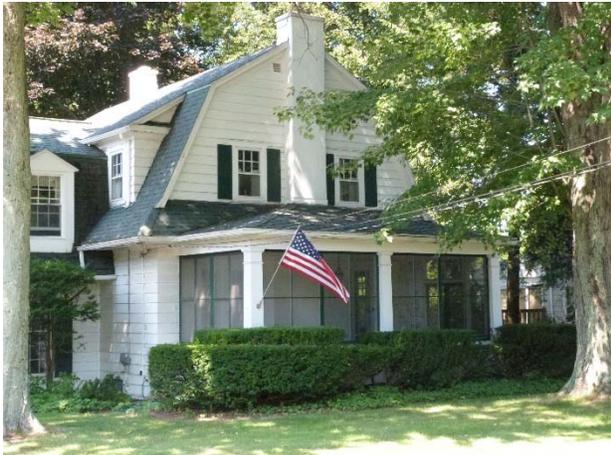
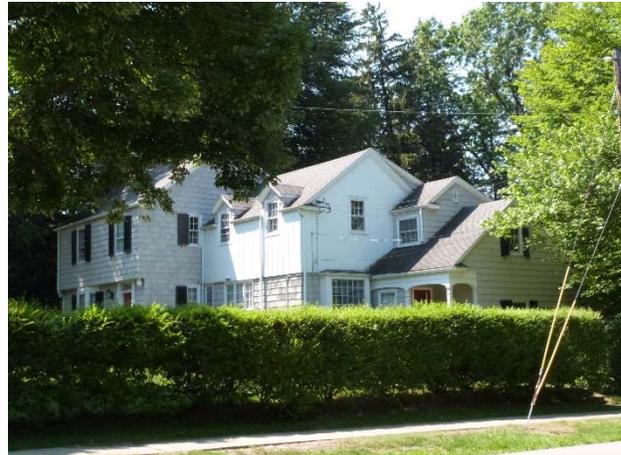
*Figure 4-3. Top: 149 S. Cayuga Rd. is a representative example of the Colonial Revival style. Its front porch was enclosed after its original construction, but was originally open. Bottom left: 193 S. Cayuga Rd. is a representative example of the Dutch Colonial style, identified by its gambrel roof with dormers. Bottom right: 185 S. Cayuga is an example of the Garrison Colonial style, identified by its overhanging second floor.*

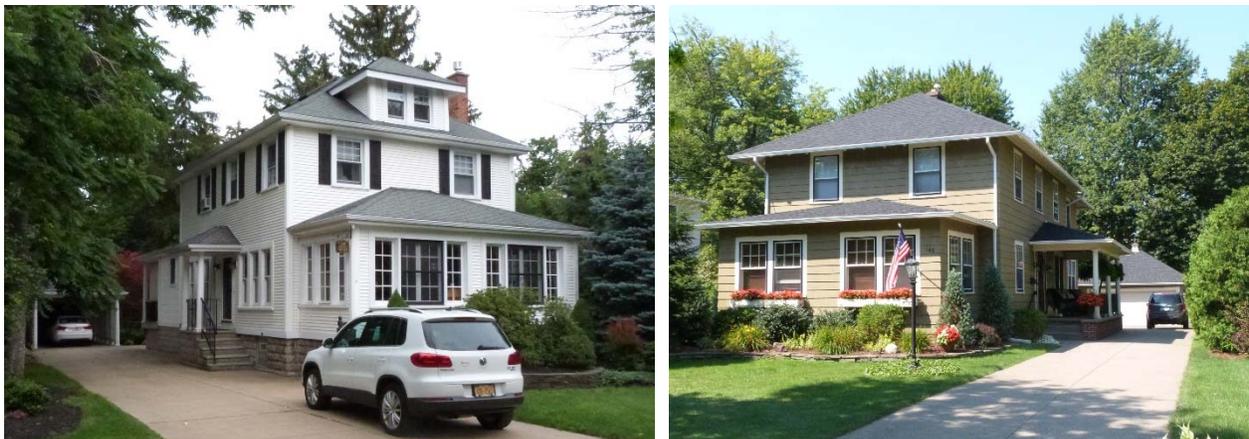
Figure 4-5. Examples of American Four Squares along S. Cayuga Road. Left: 122 S. Cayuga Rd., right: 145 S. Cayuga Rd.

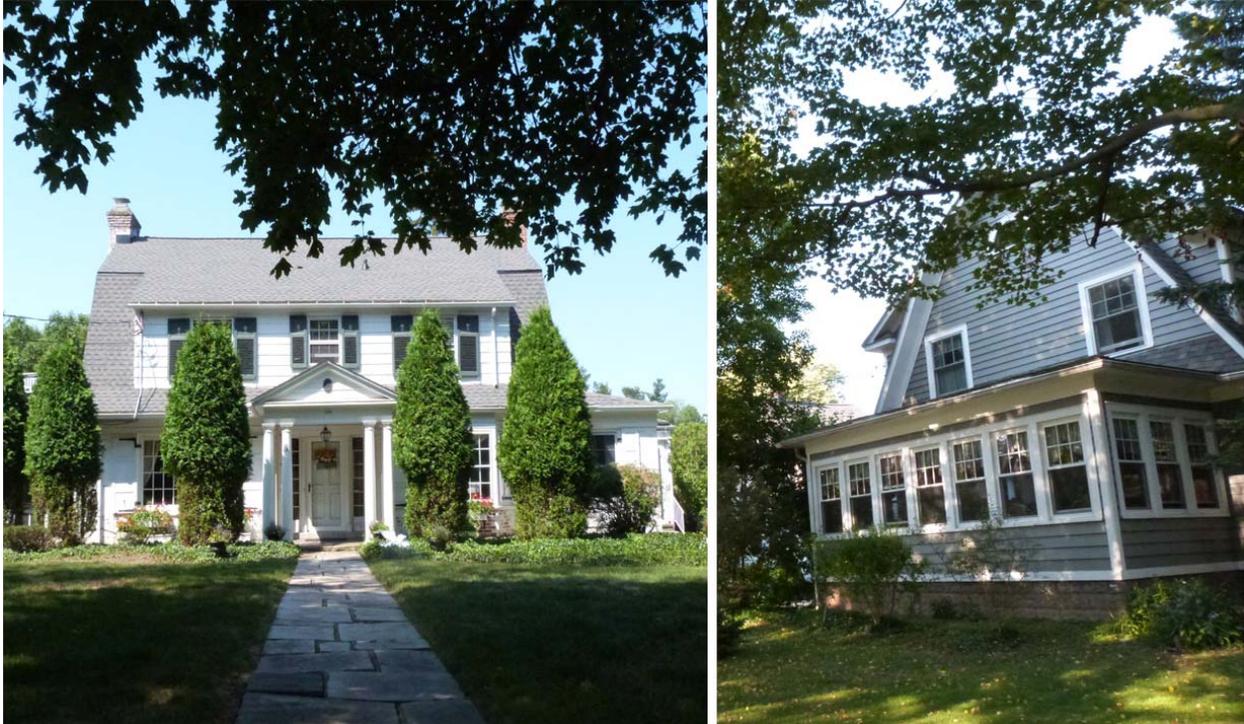
*Figure 5-5. Contrast between homes within the Williamsville Park subdivision along S. Cayuga Rd. and along the western streets of the subdivision. Both constructed at a similar time in the Dutch Colonial Revival style, the home at left (situated along S. Cayuga Rd.) is a much larger and more elaborate representation of the style than the one at right (along Pasadena Place).*

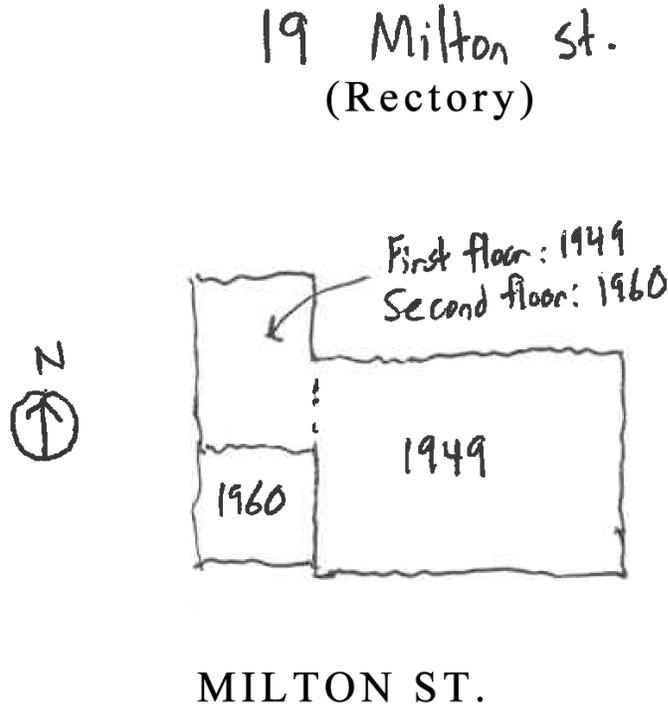
**Image #1:** Rectory Building Chronology Diagram

The rectory is a two-story brick side-gabled Colonial Revival style home set behind a front yard. Home is three bays wide with center entrance featured a columnated wood surround with entablature above. A one-bay wide two-story aluminum-sided addition containing a one-car garage and living space above is located just west of the main block and set slightly back from the front elevation plane. All windows are 6/6 double-hung vinyl replacements with simulated muntins. The roof of both the main block and addition is asphalt shingle.

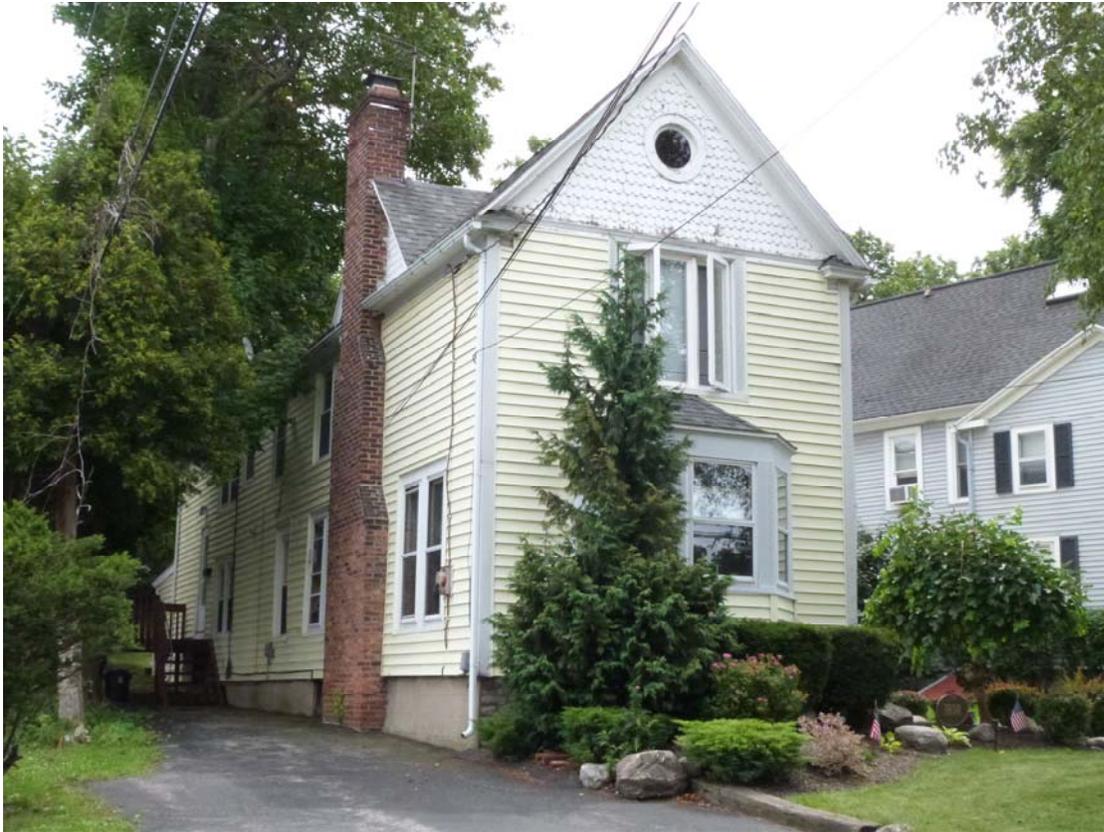
**Photo #1:** Looking southeast

Medium integrity. Original footprint and massing and most window openings appear to be original, per historic photos and maps. Lessened integrity due to partial replacement of windows with vinyl replacements and replacement of second floor front elevation window with non-compatible casement arrangement. First and second floors have been vinyl sided, which has lessened the relief around door and window frames. However, aesthetic is similar to clapboards that are visible on historic photo, so does not lessen integrity.

Two-story frame home, one bay wide at front elevation, cross-gable plan. Rubble stone foundation, vinyl sided first and second floors, fish-scale wood shingles at faces of third floor gable faces, asphalt shingle roof. 1/1 double-hung windows typical, mixture of wood and replacement sash. Unique features include porthole windows in gable faces and entablature at door surround. Brick chimney at north elevation.

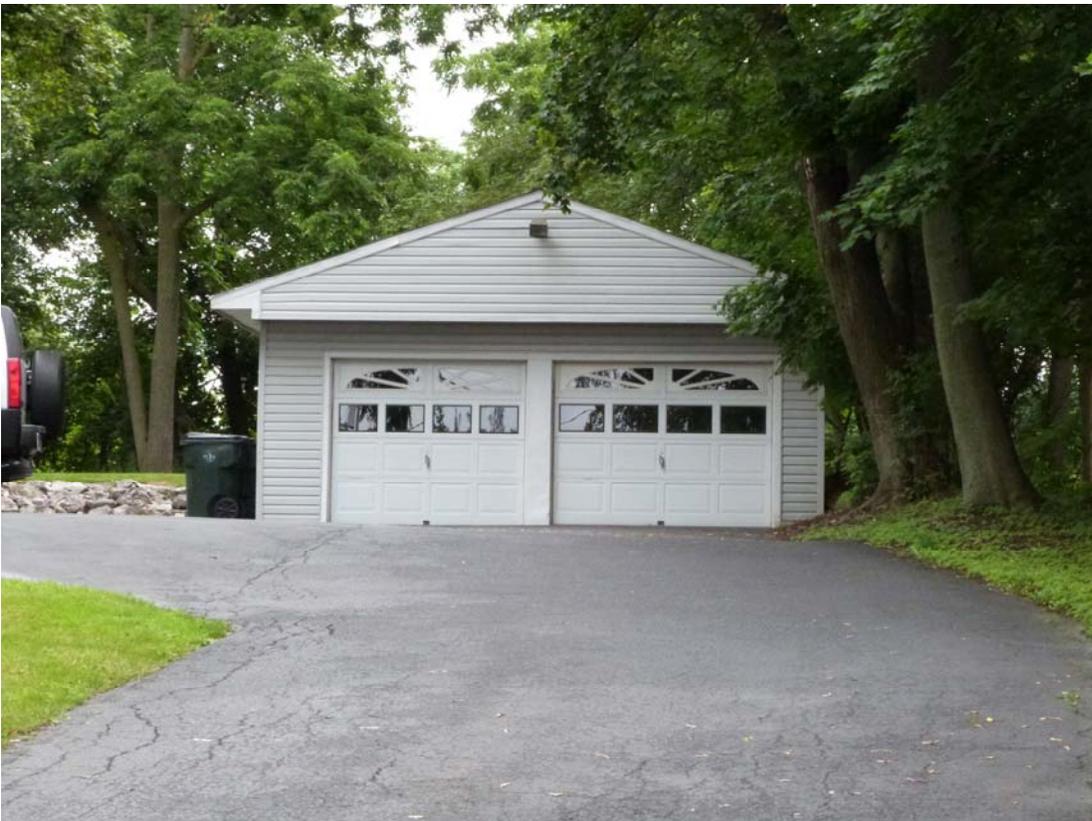
**Photo #2:** Closeup view of existing garage at the rear of 54 S Cayuga

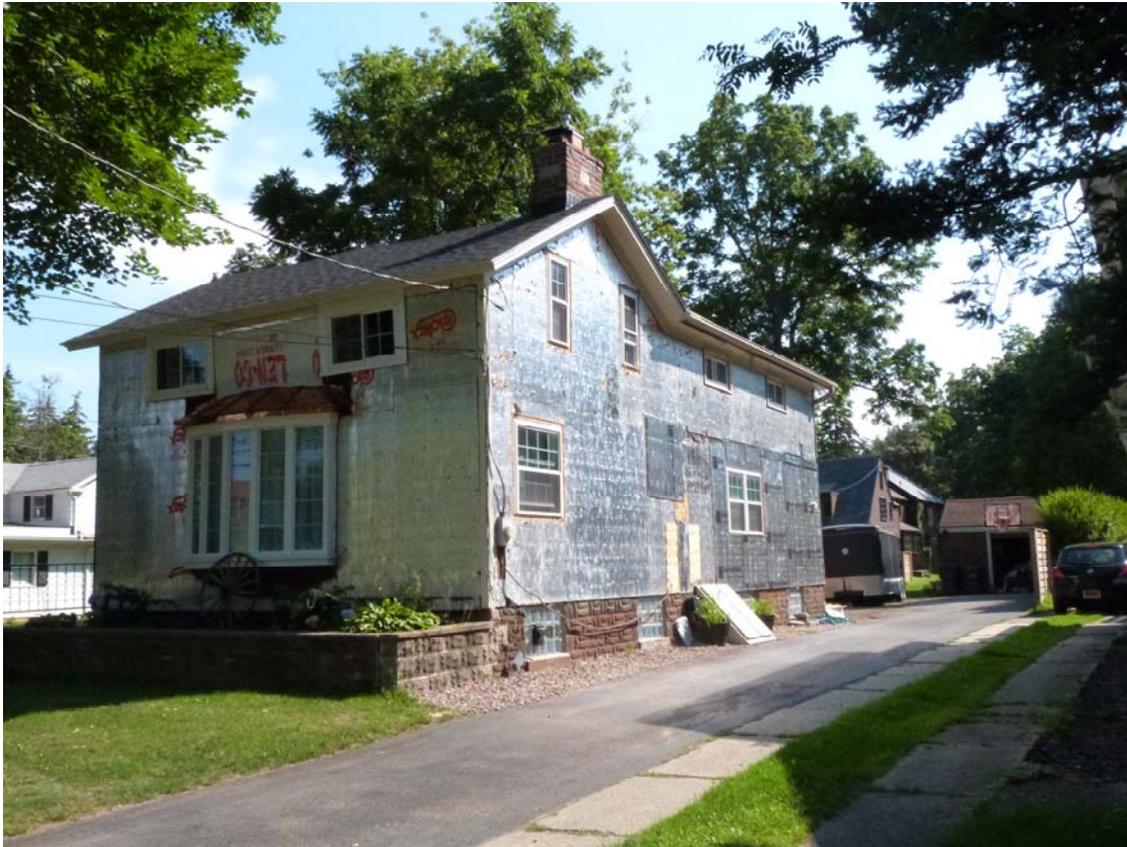
**Photo #4:** Looking northeast during exterior alterations, taken early August 2017

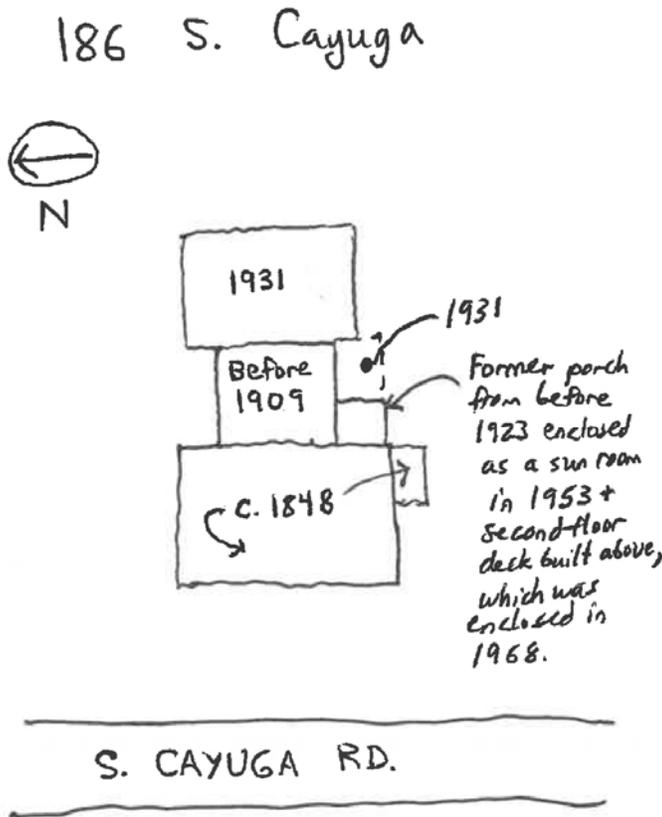
**Image #1: Building Chronology Diagram**

**186 S. Cayuga Rd. (Israel Colburn House) –**  
**BUILDING CHRONOLOGY DIAGRAM**

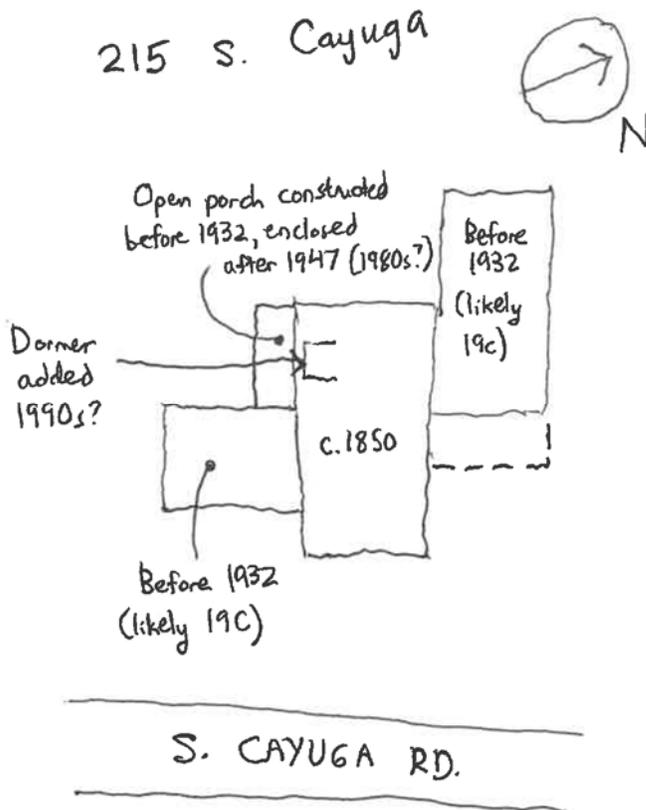
**Image #1:** Building Chronology Diagram

**211-215 S. Cayuga Rd. (George & Catherine Zent Farmhouse) – BUILDING CHRONOLOGY DIAGRAM**

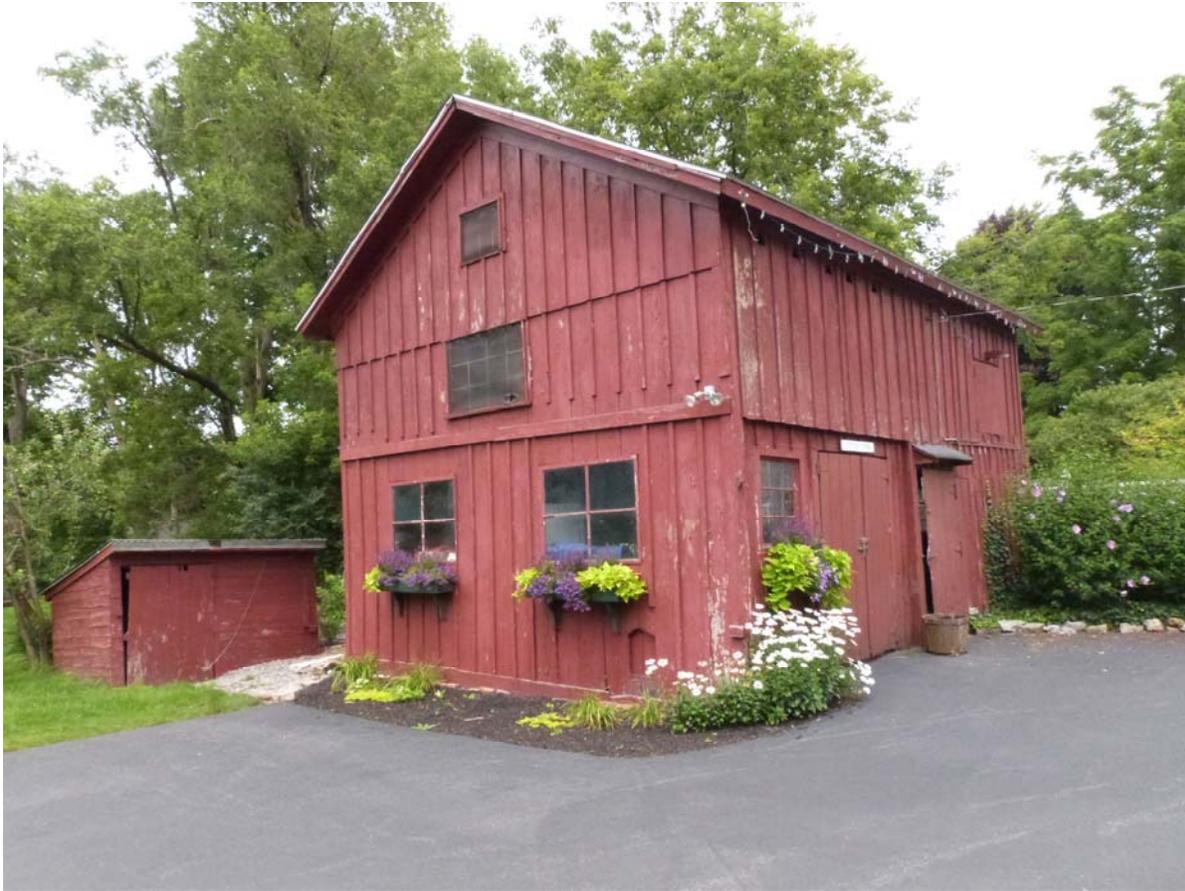
Photo #3: Barn and former chicken coop at rear of property
